Project: AGOR 28	Contract No.: N00014- 12-C-0305	Shipyard: Dakota Creek Industries  Program Officer:		
Prepared by:	Date:			
Paul D. Bueren	30 March 2015	Robert (Tim) Schnoor		
Scripps Institution of		Office of Naval Research		
Oceanography (SIO)		875 Randolph St		
297 Rosecrans St.		ONR 321		
San Diego, CA 98106		Arlington, VA 22203-1995		
<b>Distribution Statement A</b> : Approved for public release; distribution unlimited.		Report No. A002.075

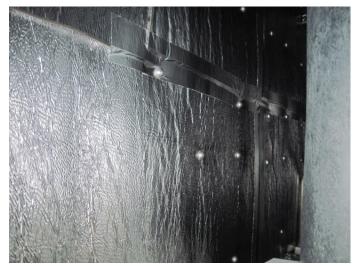
Stack Interior

- Main Deck Noise Levels Stack noise on the main deck exceeds the requirements to the extent
  that exposure without ear protection causes discomfort. The noise seems to emanate from the
  ends of the diesel exhaust pipes. NCE, DCI and the Government are very much aware of the
  issue.
